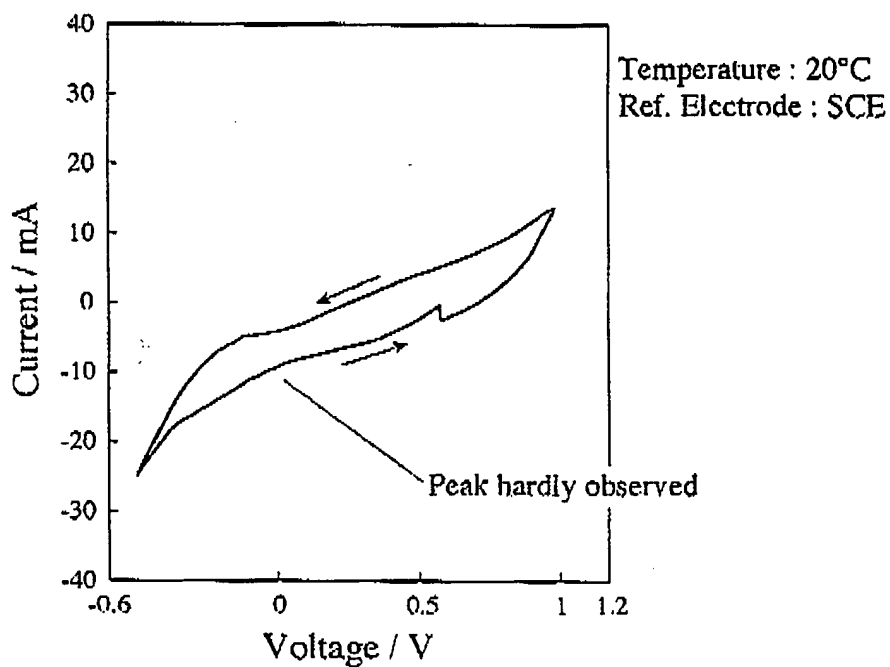
## Reference Figure 1

Membrane Electrode Assembly  
before Aging

Poor Contact

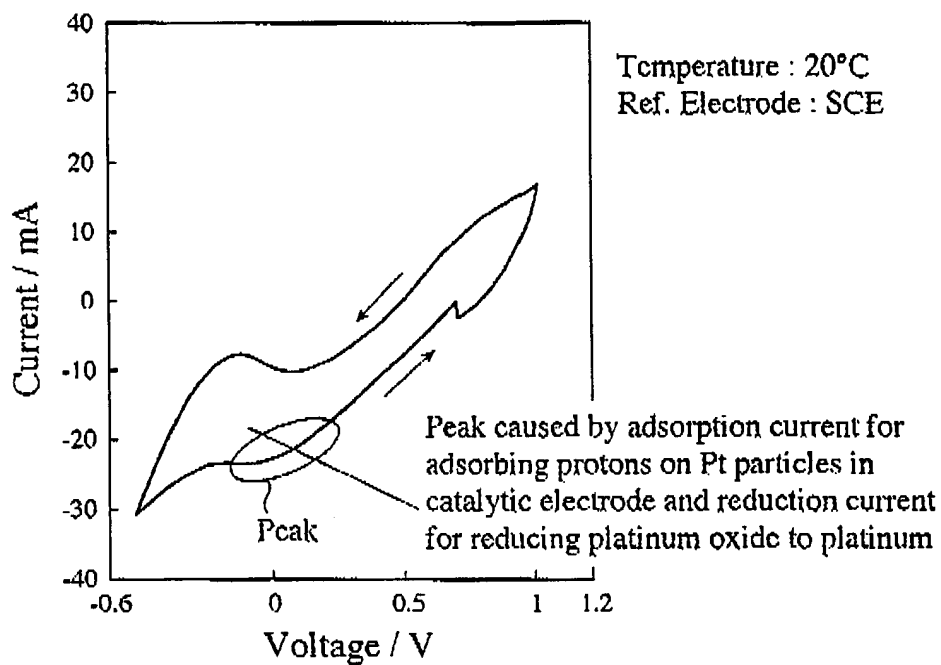
## Reference Figure 2

Membrane Electrode Assembly  
after Aging

Tight Contact

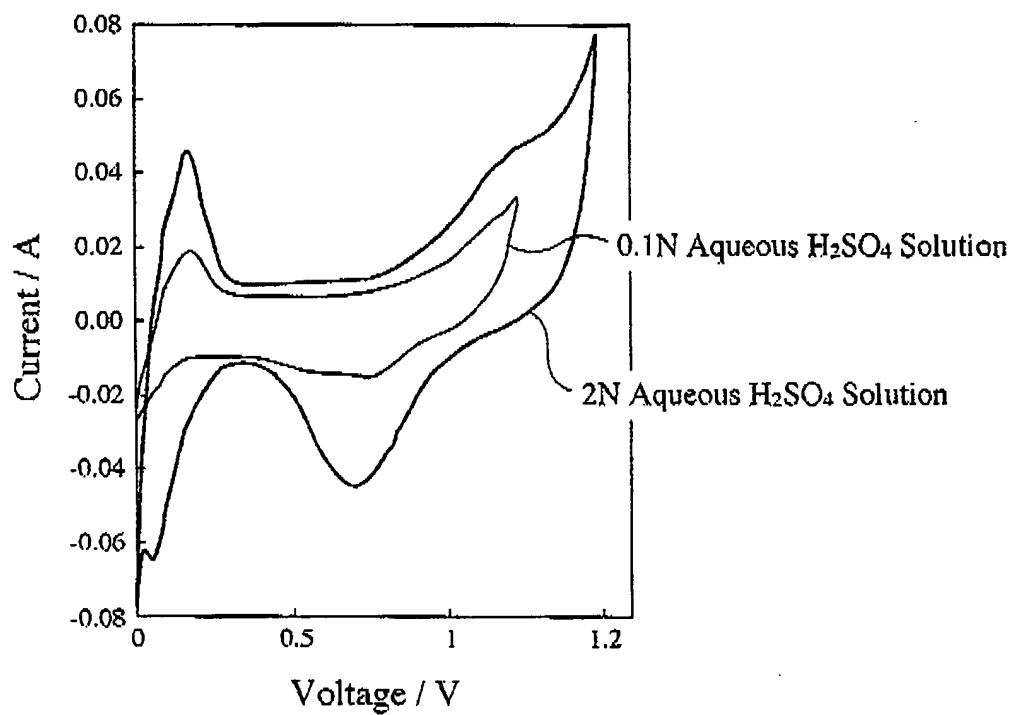
### Reference Figure 3

CV curve of Electrode without Polymer Electrolyte
